REMEDIATION OF FIRE-INDUCED HYDROPHICITY HEAP'S PEAK – SAN BERNARDINO NATIONAL FOREST

BIO REMEDIES, LLC
August 1, 2004

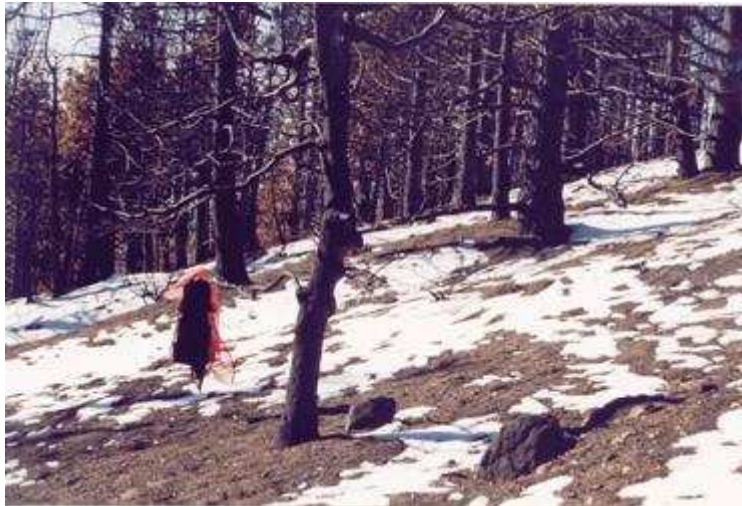
Site just prior to treatment

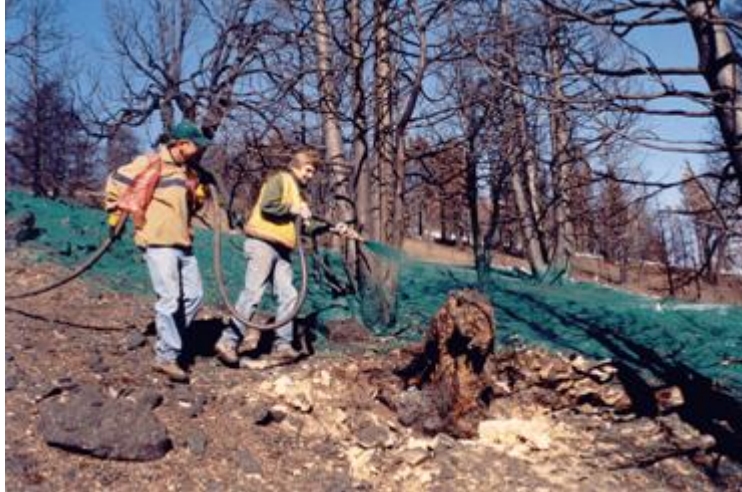
Applying Hydromulch

- Hydro-mulch only (hydro mulch courtesy of Fiber Marketing International, Inc.)
- Hydro-mulch with 92 lbs. of MicroRestore (MR) (equivalent to a rate of 400 lbs./acre)
- Hydro-mulch with 92 lbs. of Terra Pro-inoculated MicroRestore (TPMR) (equivalent rate of 400 lbs./acre), with the equivalent of 100 lbs. per acre of an organic protein (nitrogen) source

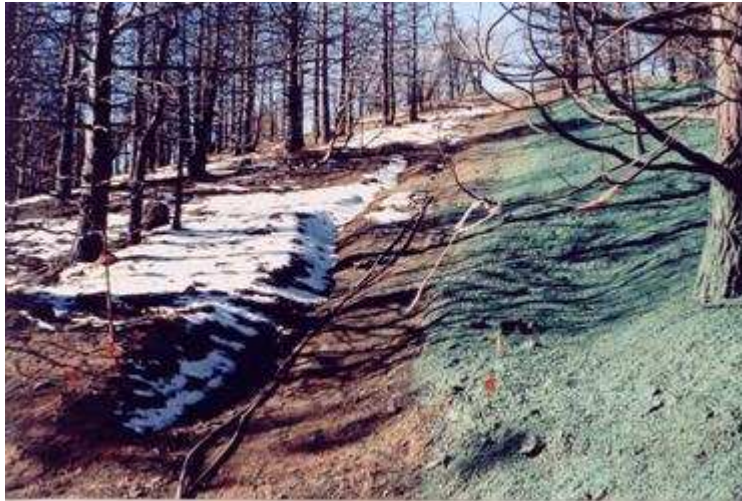
Control Area – left, Treated Area – right

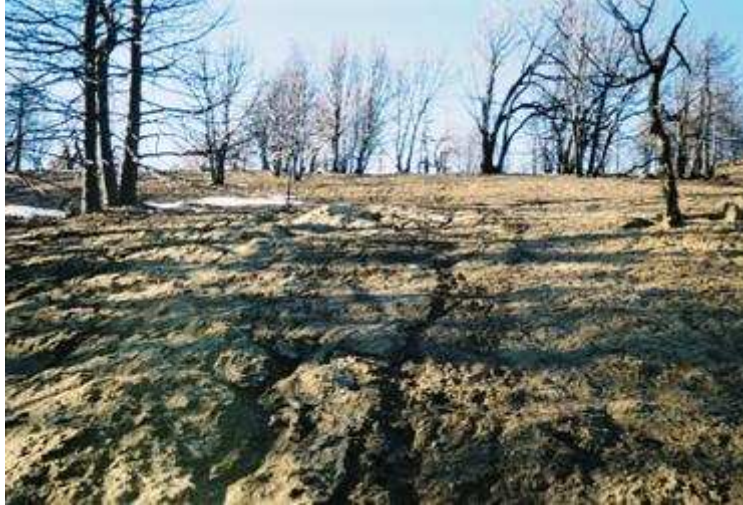
Rilling from heavy rains

Soil stabilization was good throughout most of the project during the test period, mid-December through April, demonstrating the performance of the Fiber Marketing hydro-mulch. Heavy rains during late January caused moderate rilling along the NE part of the project.

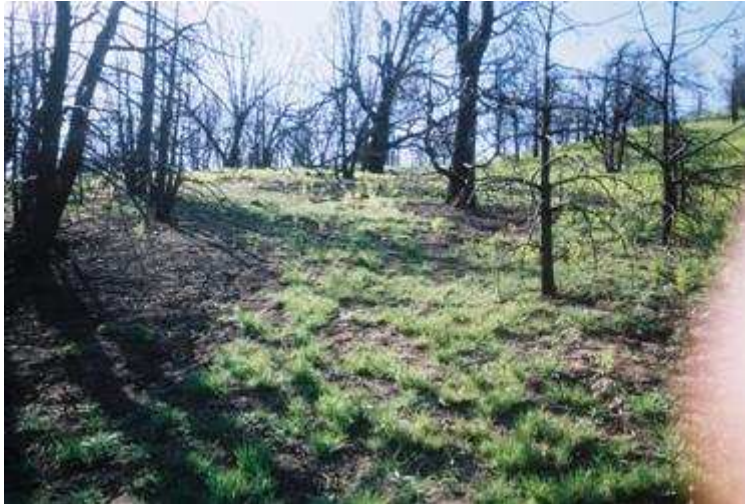
April, 2004 – vegetation established in open areas away from clusters of burned trees

Re-growth of native vegetation by April of 2004 was good in the upper slope and mid-slope areas, particularly away from burned trees or clusters of trees. The lower slope area (originally heavily treed) was still bare for the most part, which we believe was related to the severity of the burn in that area destroying native seeds and roots. The amount of vegetation cover did not appear to be a function of whether or not the ground was treated. The severity of initial burn was interpreted to have been the major control at that point in time, as non-treed areas regenerated more rapidly.

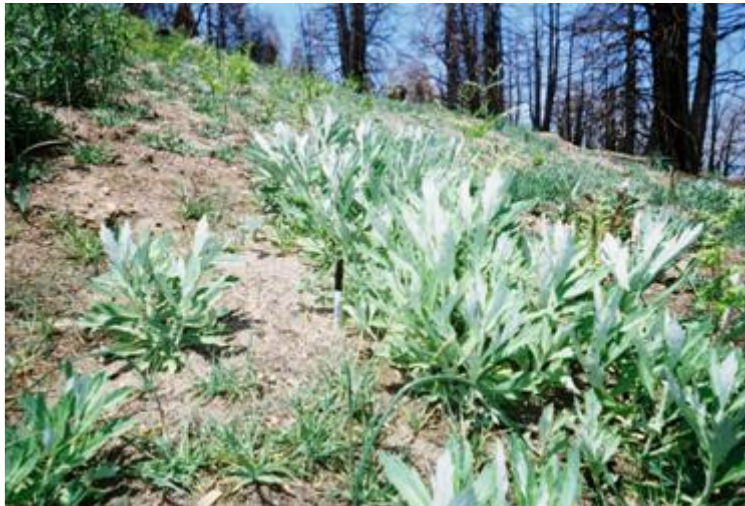
April, 2004 – vegetation in open areas

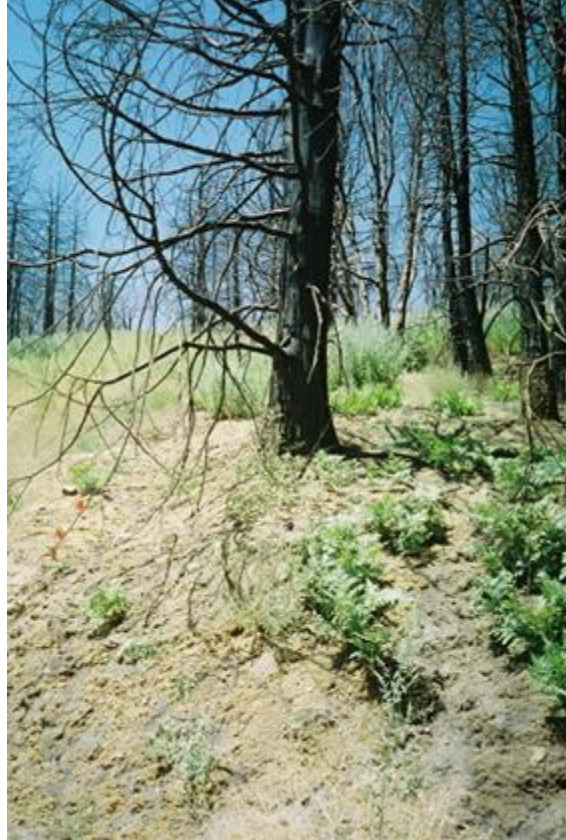
Ferns growing in TPMR area – control on left

An important change in the vegetation was noted during the July, 2004 examination. It was noted that in the two-month period since April, ferns had been established and were growing to heights of 6 to 8 inches in the TPMR area and in the MR area. This step in the succession of species is very significant as it is interpreted to be due to a maturing of soil biota and a quicker return to natural conditions. As ferns are among the species known to establish an association with endomycorrhizae, it is interpreted that the fungal community in the treated areas had re-generated much more quickly in these two areas than in the untreated areas.
